SUBSYNCHRONOUS VIBRATION IN A LARGE WATER FLOOD PUMP

James E. Corley

Supervisor, Rotating Equipment

Arabian American Oil Company

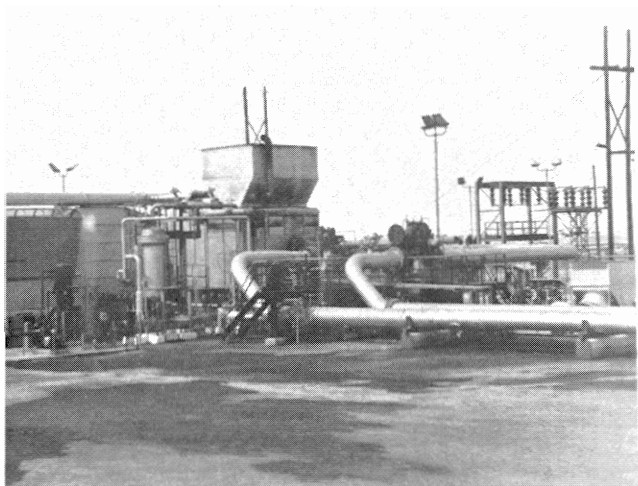
Figure 3. Water Injection Pump Train.

The $16 \times 16 \times 20$ DVMF shipping pumps for the injection system is a large two stage, double suction volute pump and is directly driven by a 26,000 HP, iso rated, two shaft combustion gas turbine. Suction to the shipper is supplied by a $24 \times 24 \times 30$ TVS booster pump which is driven off the outboard end of the shipper pump through a step-down gear. The shipper pump has a rated capacity of 20,000 GPM at 3,500 feet head and 4,900 RPM. The photo in Figure 3 shows the train layout along with the suction and discharge piping.

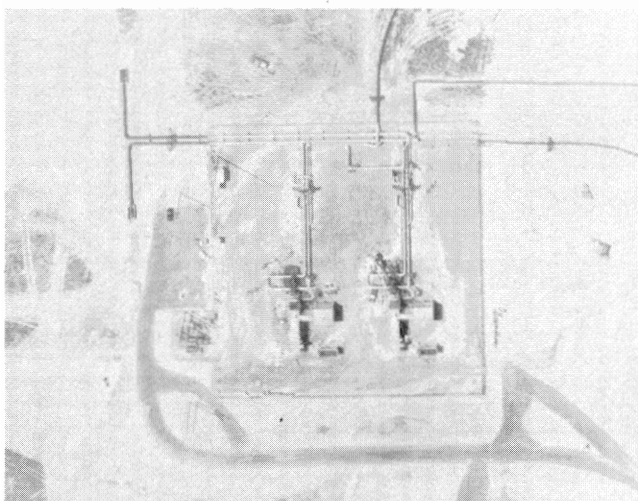
Figure 4. Aerial Photograph of Pump Station.

Suction for the booster pumps is taken from a common header which feeds two injection trains in a given plant. The booster pump then supplies suction to the shipper through a pipe loop approximately 75 feet long, which can be seen in the aerial photograph in Figure 4. The suction and discharge piping is connected to the pump through bell shaped transition pieces. These transition pieces, shown in Figures 5 and 6, were later found to be a prime factor in the sub-synchronous vibration of the pumps.
